Test Intention:

In the test 5123 we want to investigate the lifespan of a CF886.160.04 in an e-chain with a 250mm radius.

Series / No: CF886

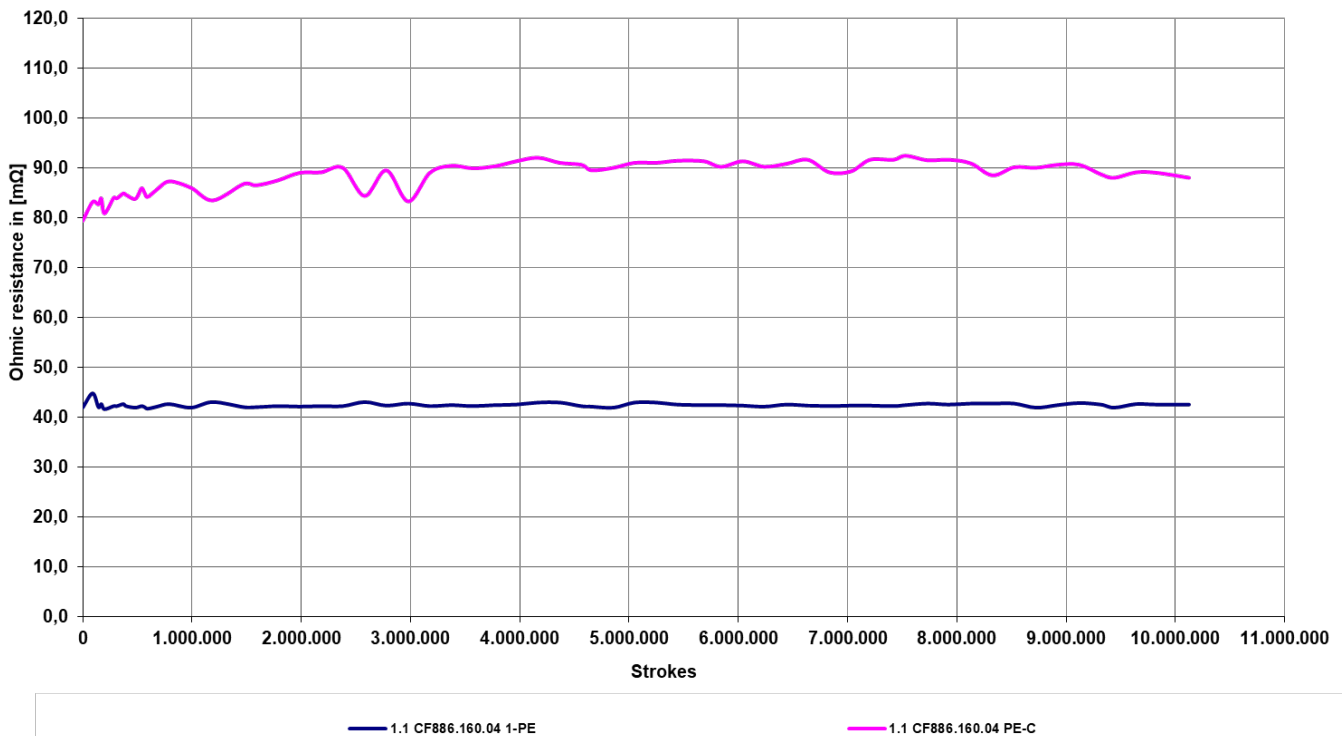
Trend of the ohmic resistances

At the 17.08.2018 we demounted the cables after 10.126.714 strokes, because we wanted to finalize the test.

The following diagram shows the trend of the ohmic resistances during the test:

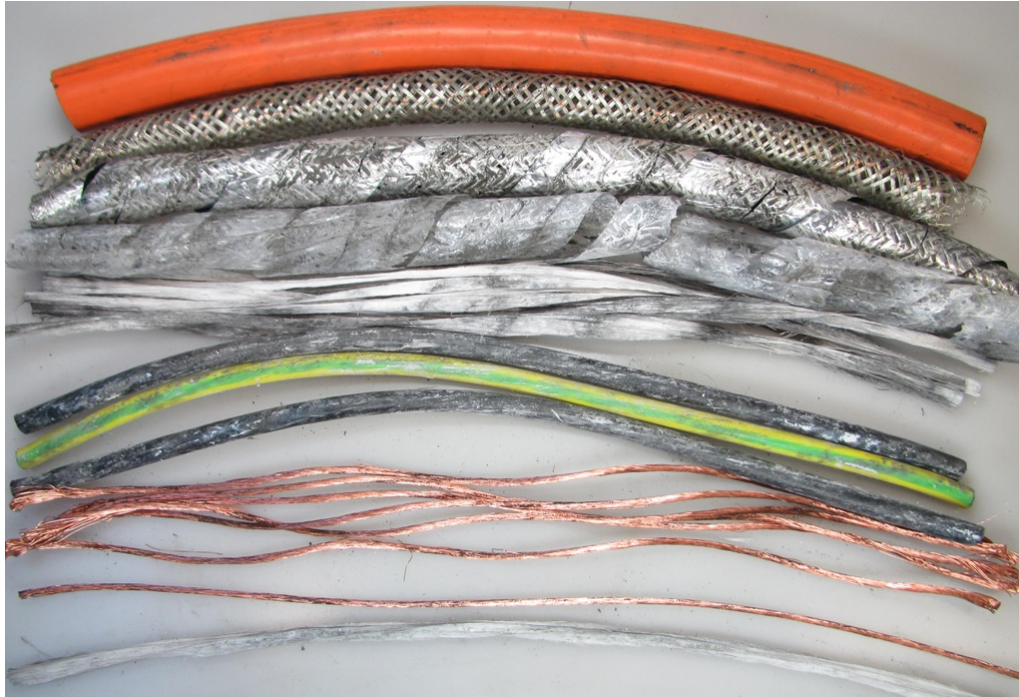
The condition of the cable no. 1.1 (CF886.160.04) after 10.126.714 strokes

Strokes	10.126.714
Condition outer jacket	O.K.
Condition overall shielding	Broken single wires
Condition banding	Ruptured
Condition filler	O.K.
Condition centre element	O.K.
Condition core insulation	O.K.
Condition conductor	O.K.
